NORTH COAST INTEGRATED REGIONAL WATER MANAGEMENT PLAN

292 - Lower Russian River Water Quality Improvement Project, Sotoyome Resource Conservation District

**2010 Austin Creek Watershed
Sediment Source Assessment
Sonoma County, California**

PWA Report No. 10086601
June 2010

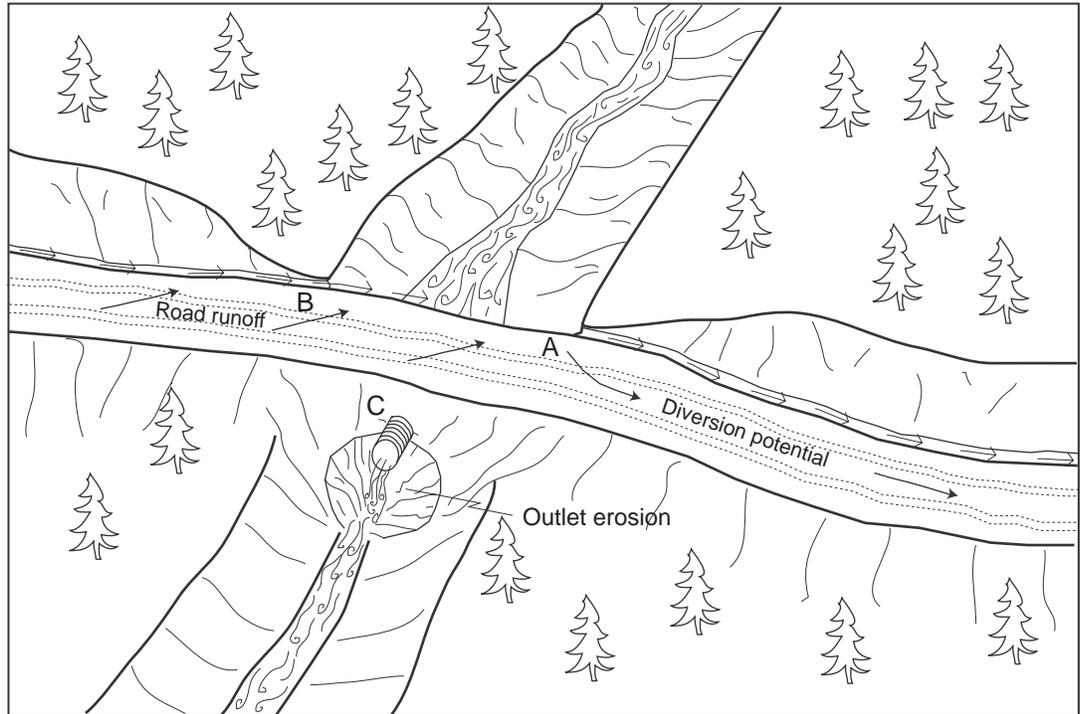
Problem condition (before)

- A - Diversion potential
- B - Road surface and ditch drain to stream
- C - Undersized culvert high in fill with outlet erosion

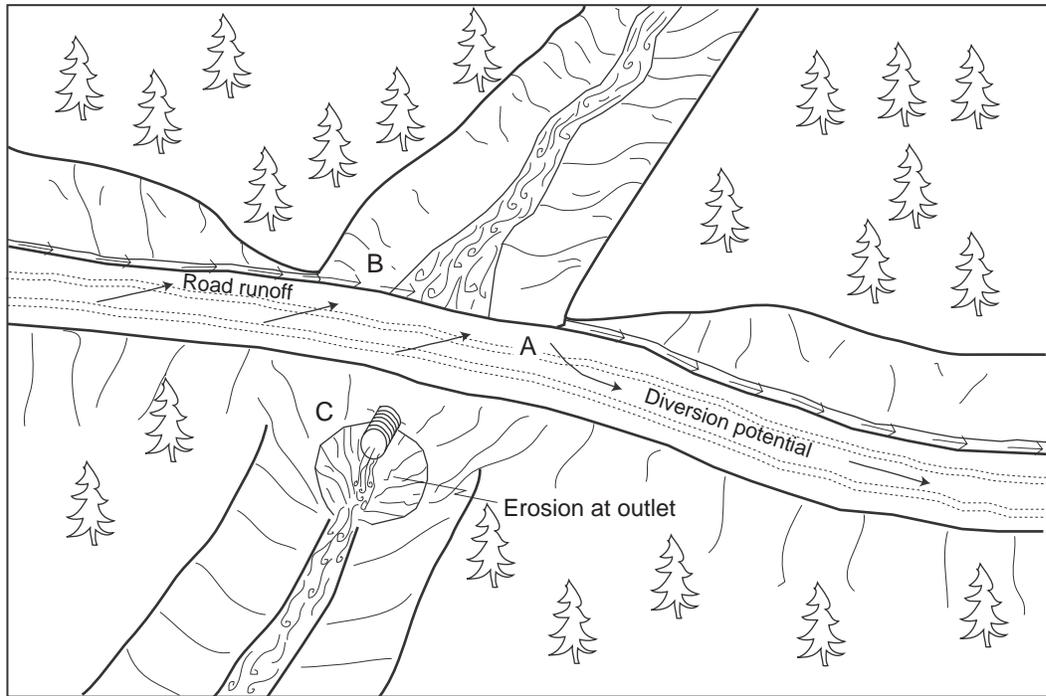
Problem condition (before)

- A - Diversion potential
- B - Road surface and ditch drain to stream
- C - Undersized culvert high in fill with outlet erosion
