# American River Basin: Antelope Creek Improvement Project

## Attachment 3: Work Plan

**Antelope Creek Water Efficiency and Flood Control Project Flood Damage  
Reduction Analysis**

**Subject: Antelope Creek Water Efficiency and Flood Control Project Flood Damage Reduction Analysis**

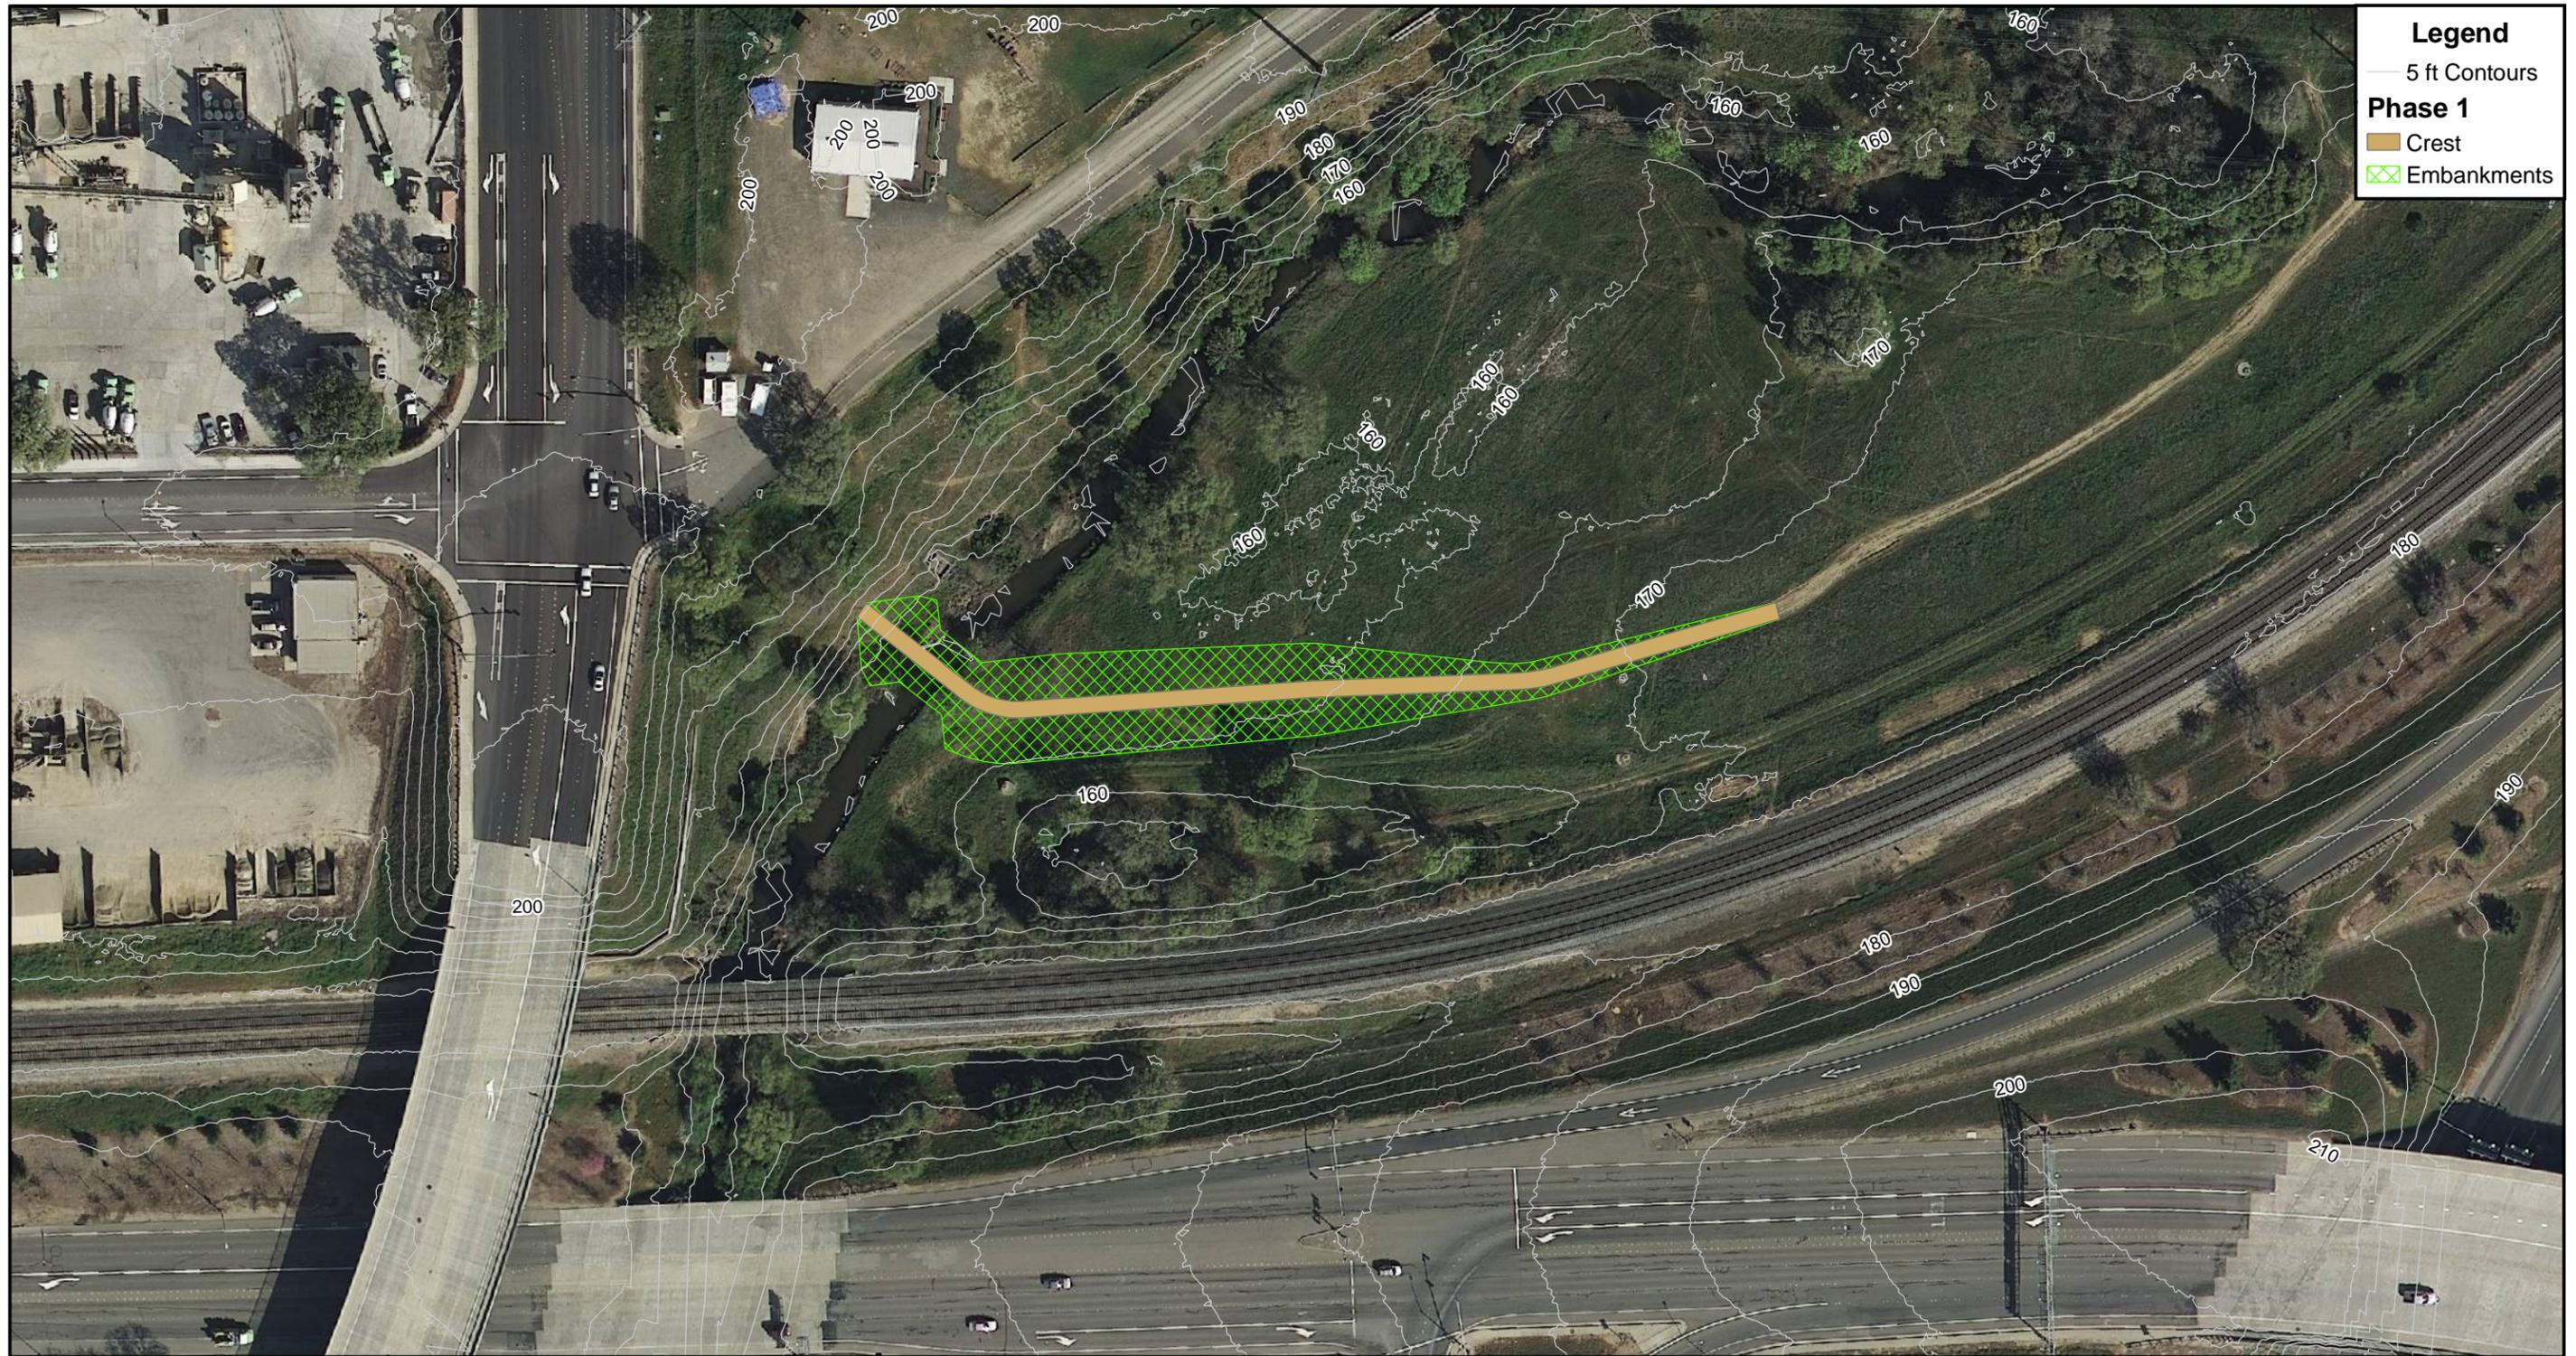
# ANTELOPE CREEK FLOOD CONTROL PROJECT - PHASE 1

The structure near Atlantic Street was modeled as a 10- to 12-foot high embankment on the floodplain with a Conspan Arch culvert with a span of 32 feet and a rise of 7.5 feet. The second weir will replace the existing bike bridge, raising the bridge deck about 4 to 6 feet. An embankment or wall will tie in the crest of the new structure to existing ground to limit overtopping to the desired area. The model assumed that the two existing 6.5-foot diameter culverts will be replaced with a Conspan Arch with a span of 20 feet and a rise of 7 feet.

The purpose of the Project is to reduce peak flows downstream from the Project site. The Project is separated into 2 phases: Phase 1 involves construction of a new structure near Atlantic Street and Phase 2 involves replacement of the existing bike path crossing with a flow control structure that would improve low flow conveyance and increase the volume impounded before being overtopped. Exhibits 2 and 3 attached to this letter illustrate the locations and a conceptual layout of the proposed weir/embankments.

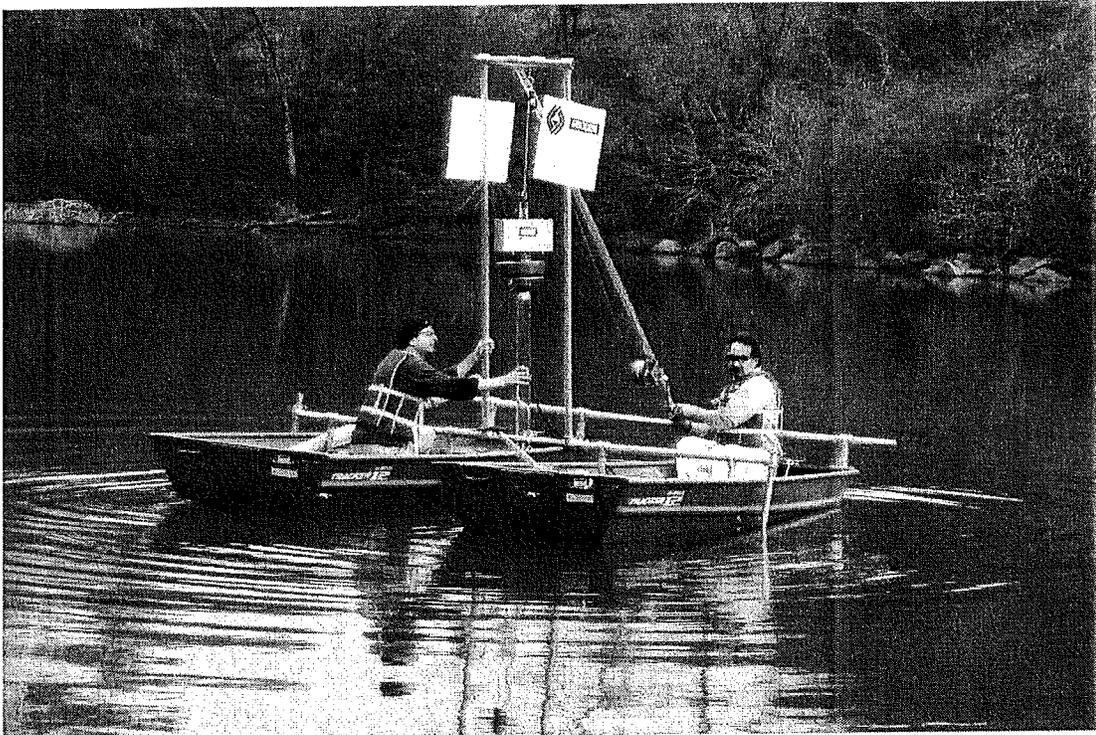
Photo No. 1 Sediment Sampling Operation at Clover Valley Reservoir

On January 28, we collected five sediment samples (VC1 through VC5) using a boat-mounted electric Vibrocore<sup>®</sup> sampler as shown on Photo 1, Figure 3. The sampler, equipped with various lengths of dedicated acrylic core tubes, was lowered into the water and vibrated until refusal conditions were encountered. Upon recovery, we capped the cores to reduce disturbance of subsequent handling and transport. We transported the cores to our office for subsequent logging and submittal for physical and chemical testing. Photographs of the sediment samples are presented as Photos 2 through 4 on Figures 3 and 4.

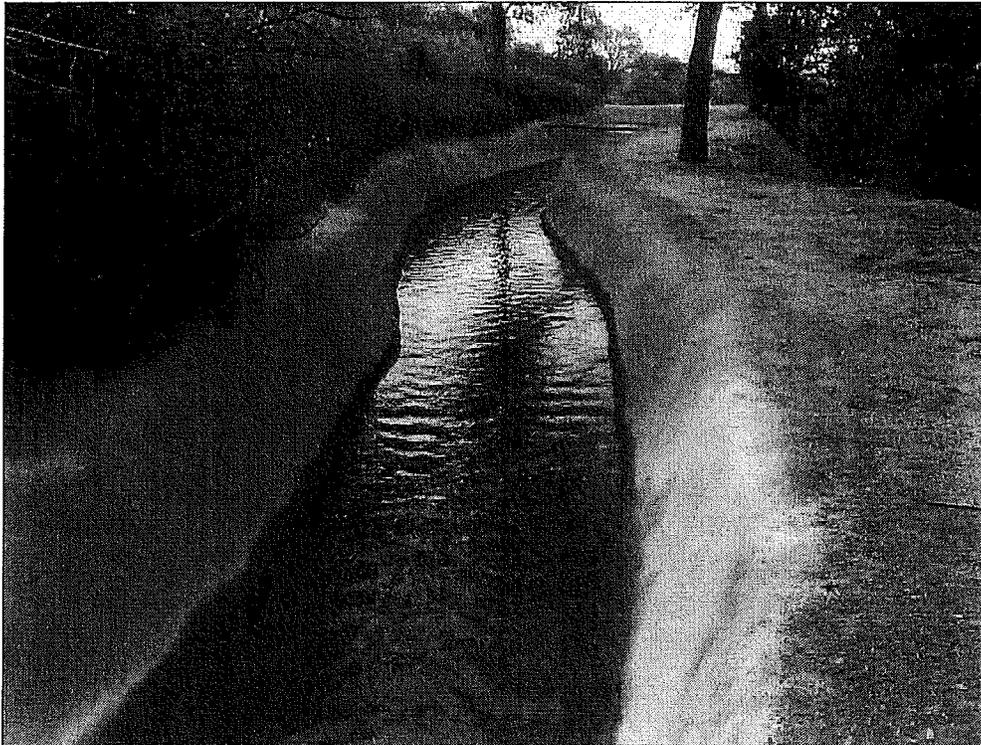
Photo 2 – Antelope Canal. Facing upstream along lined portion of canal.

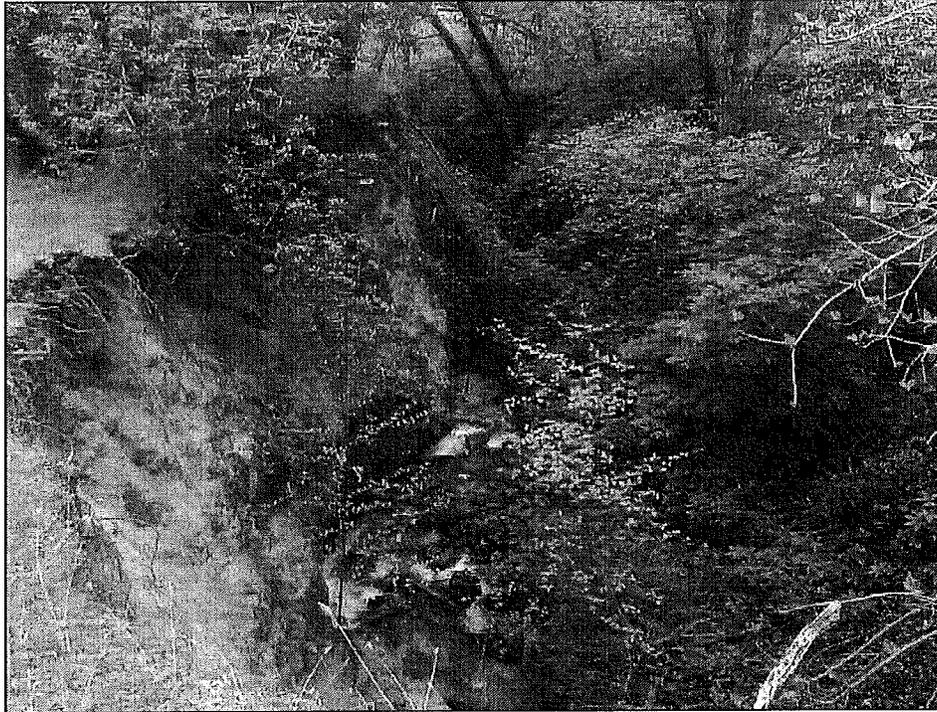
Photo 3 – Antelope Canal.  
Facing downstream between unlined portion of canal and railroad tracks.

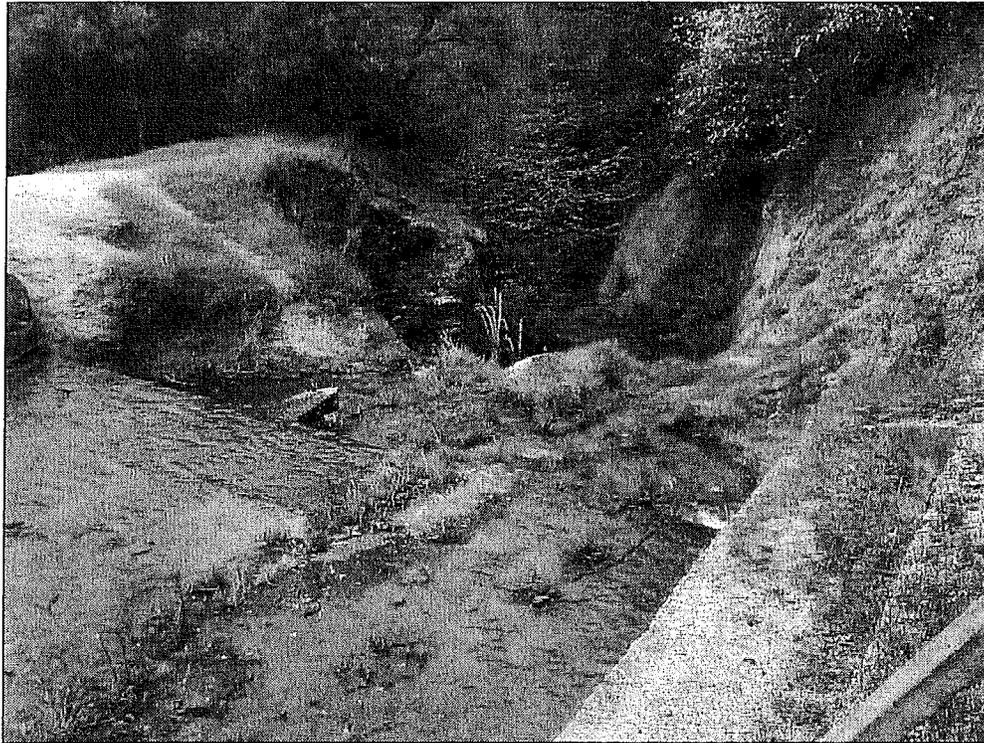
Photo 9 – Clover Valley Creek. Facing downstream, with spillway of dam in foreground.
