Project 4: City of Goleta,

San Jose Creek Capacity Improvement and Fish Passage Project

**SAN JOSE CREEK FLOOD CONTROL CHANNEL
PHYSICAL HYDRAULIC MODEL OF FISH PASSAGE IMPROVEMENTS**

Subject: Geotechnical Findings and Recommendations for Type Selection for the San Jose Creek Capacity Improvement Project, Goleta, California

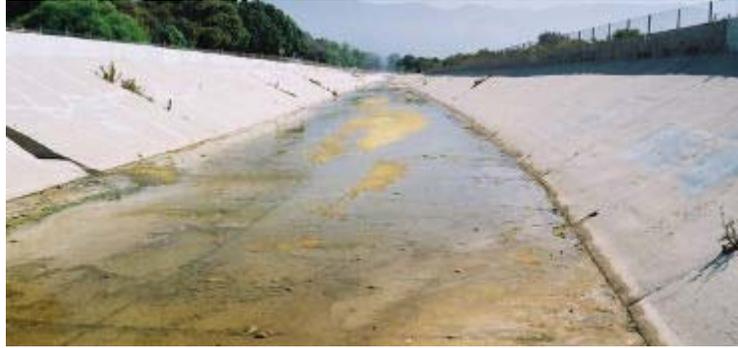
Description: This entire reach of San Jose Creek was created by realigning the stream from its former channel to the west into this trapezoidal concrete channel, which was built by the Army Corps or Engineers (pers. comm. Treiberg). Portions of the original natural stream channel continue to exist to the west, but the upstream end of this channel has been covered around Hollister Avenue and confined by development. The total length of the concrete lined channel measured 0.78 mile, using GPS. Stream flows are unconfined and spread out over the bottom of the lower channel and then become more confined in the middle and upper reaches as the slope increases. The lowest reach of the channel is relatively flat, but the slope gradually increasing to 1-2% at the upstream end. Under the Hollister Avenue Bridge the concrete channel measured 20 feet wide on the bottom and 9 feet tall to the bridge bottom. The channelized reach is currently maintained by the SBCFCD (pers. comm. Treiberg).

Condition: The channel is in poor to fair condition with significant concrete wear and several holes completely eroded through the bottom. A total of five significant holes through the concrete were observed. The channel walls are cracked in many places with vegetation growing through the concrete in several locations.

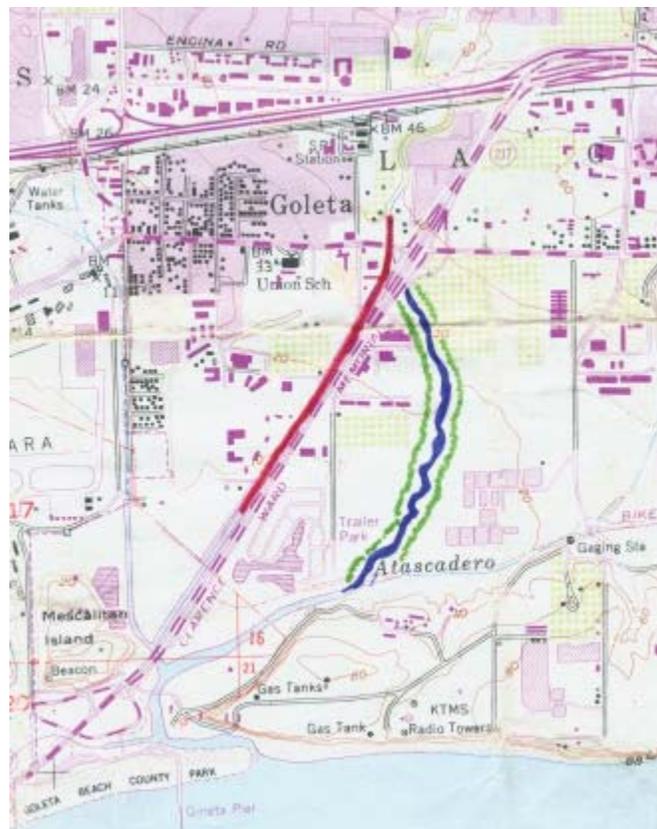
The above maps shows a rough conceptual drawing of the newly created lower San Jose Creek in blue with surrounding riparian buffer in green. This area is currently being used for agriculture. The existing, confined concrete channel is shown in red. The natural stream channel of San Jose Creek can be seen extending form the upper end of the concrete channel to Highway 101. Connecting the natural creek upstream of Hollister Avenue across Highway 217 may require the construction of a bridge(s), but may work well with Highway 217 modifications being discussed.
